Asbestos Good Faith Limited Survey

**House #297
1120 No. Alder
Tacoma, WA 98416**

**University of Puget Sound
Facilities Maintenance, 1500 N. Warner Ave.
Tacoma, WA 98416**

RE: Lead Paint Report for University of Puget Sound, House #297

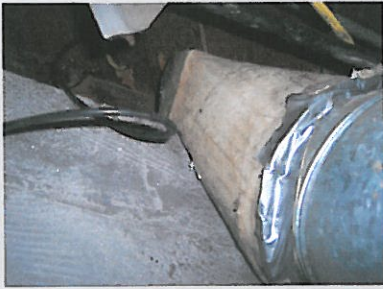
PHOTO 1

CJ01

BASEMENT

CEILING

DUCT INSULATION

**ALL MATERIALS IDENTIFIED AS ASBESTOS,
CONTAINING 1% OR GREATER,
MUST BE REMOVED PRIOR TO DEMOLITION OR
RENOVATION**
